# Manhole Inspection Summary

Manhole # S13CC\_027MH

**Location** Address: **REAR 1116 POPLAR GROVE ST** Cross Street: **WINCHESTER ST**

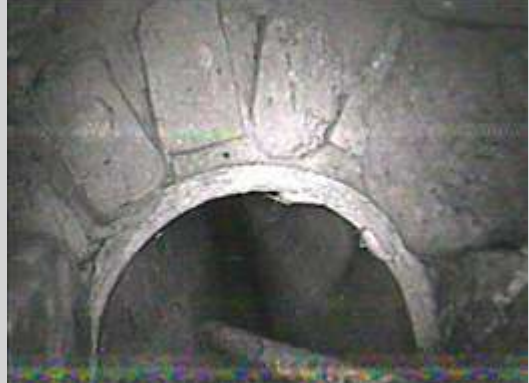
12 O'Clock Outflow

8 in. Circular Gravity Sewer  
Pipe Out @ 12 O'Clock

Pipe Height: (in.) Direct  
Pipe Material: **Clay** ☐ Pipe Lined  
Invert Depth: **10.18** (ft.) Flow Characteristics: **Slow**  
Deposits: ☒ None ☐ Mud ☐ Sludge ☐ Debris ☐ Grease  
Silt Depth: (in.) Deposits Extent:  
Infiltration: **None** Pipe Seal Cond: **Sound**
